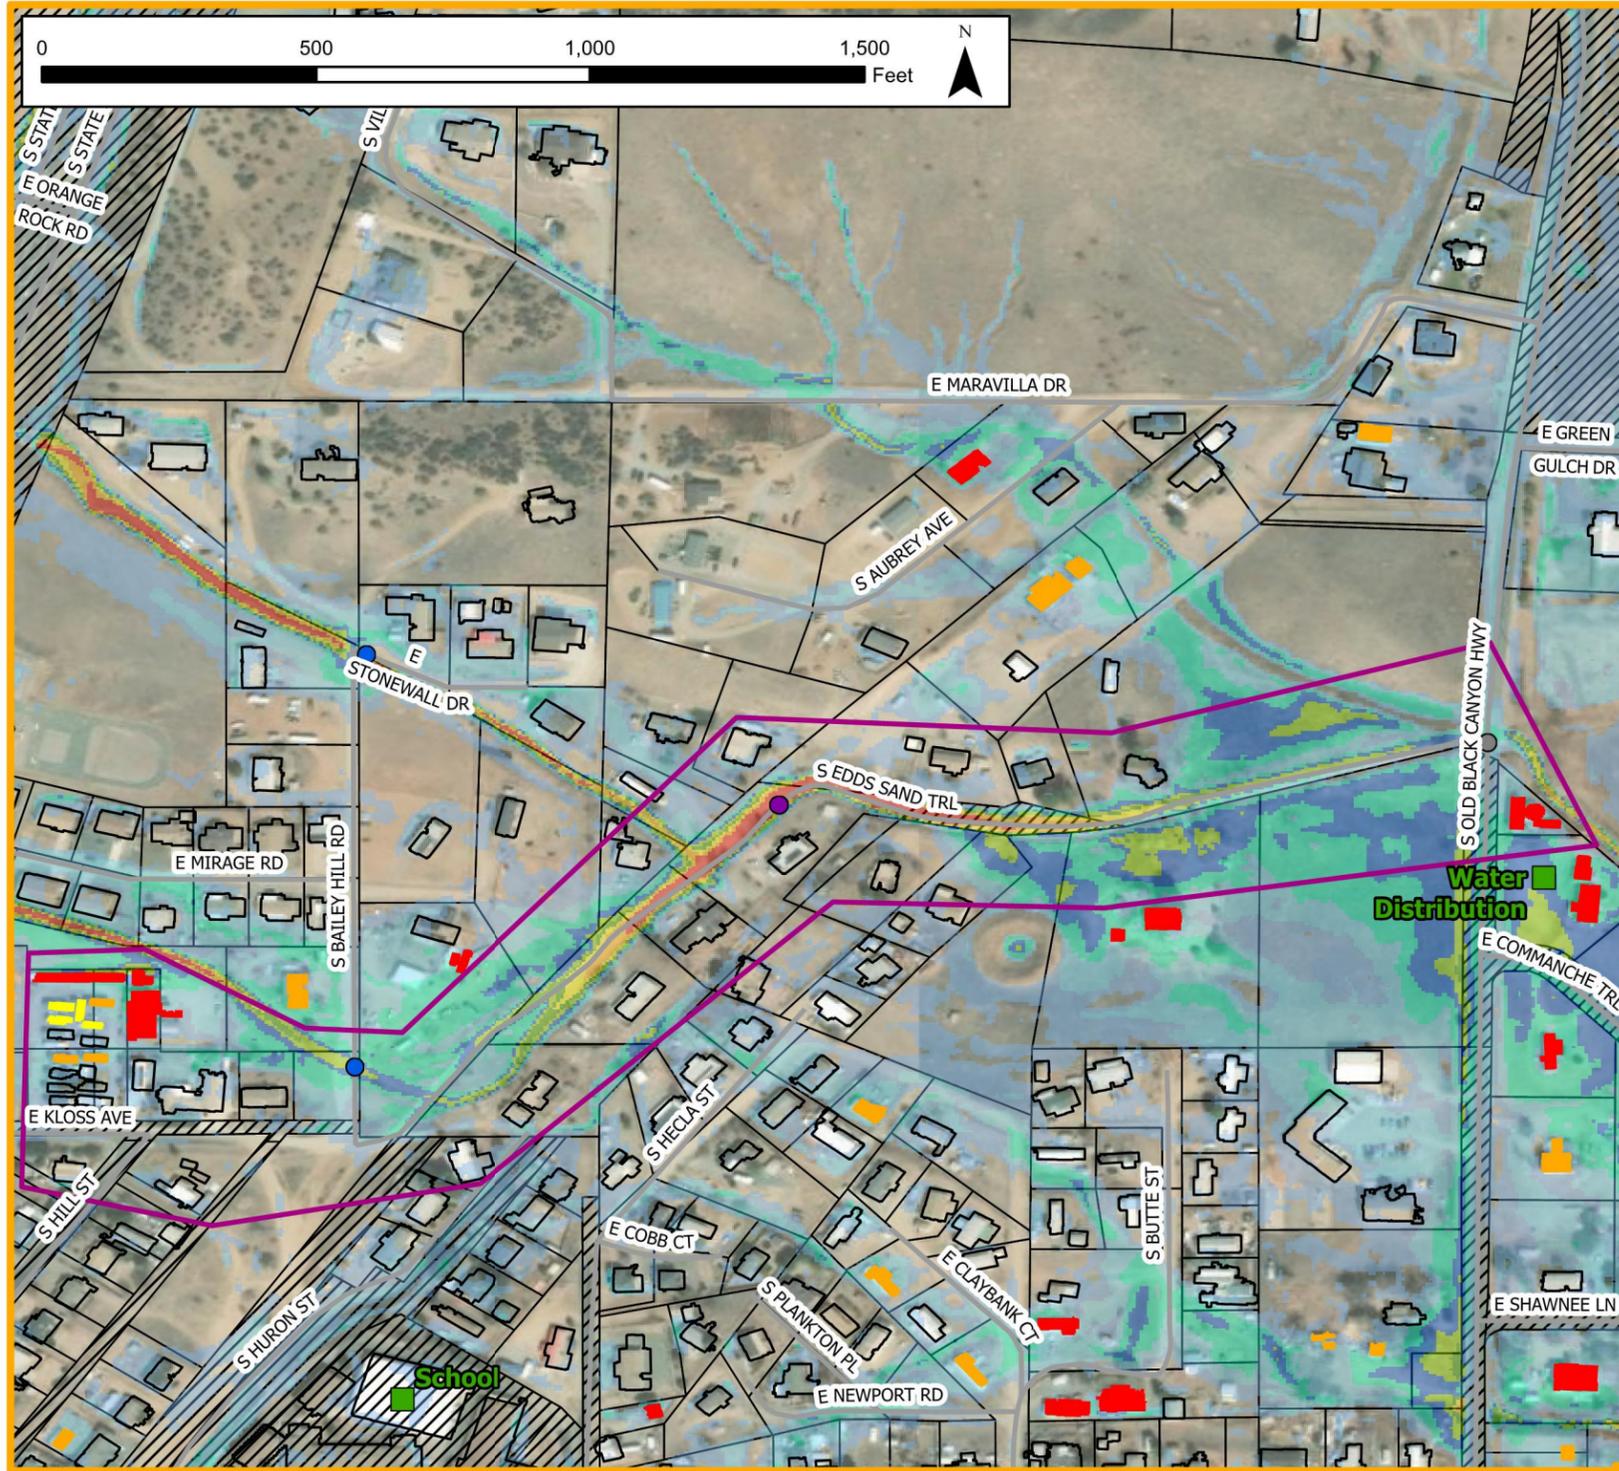
LOCATION DESCRIPTION

Location: This area includes Edds Sand Trail and extends from Old Black Canyon Highway in the east to the intersection of Hill Street and Kloss Ave in the west. It also encompasses the southern portion of Bailey Hill Road. Critical infrastructure within this area includes the water distribution building located on Old Black Canyon Highway.

Problem Statement: This area was identified by the Town and County prior to starting the project. Edds Sands Trail is the primary conveyance for the wash and floods during storm events. During the public meeting, it was brought up that the southern end of Bailey Hill Road floods as well as Edds Sand Trail, cutting off access to Bailey Hill Road, Mirage Road, and Stonewall Drive.

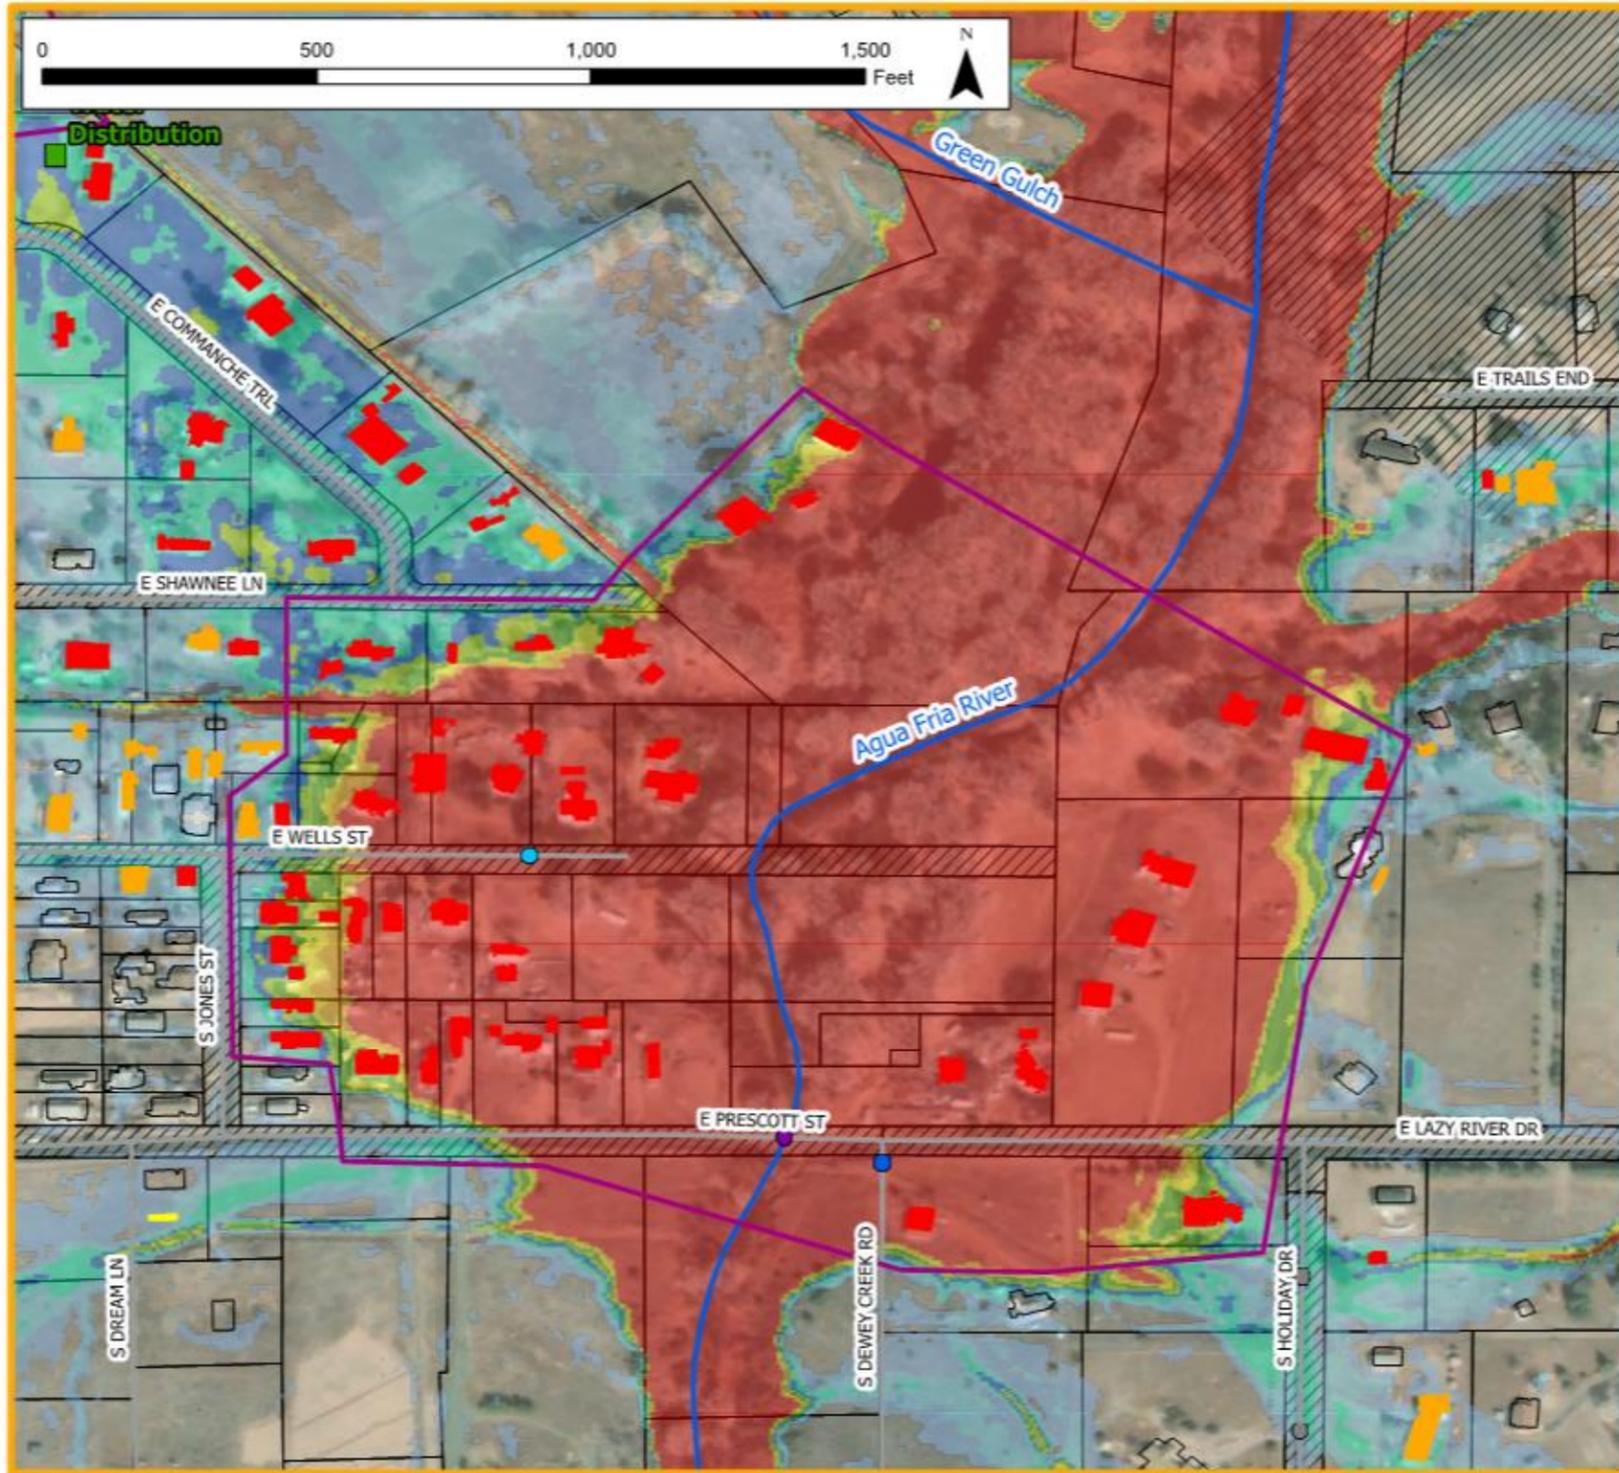
LOCATION DESCRIPTION

Location: This area includes the low water crossing on Prescott Street at the Agua Fria River and the surrounding residential areas along the river.

Problem Statement: This area was identified by the Town and County prior to starting the project. During the public meeting, it was noted that the Prescott Street crossing had failed and was closed. The major concern is that the flow depth and flooding of the Agua Fria River at Prescott Street completely cuts off access to the roads east of the Agua Fria from SR 69.

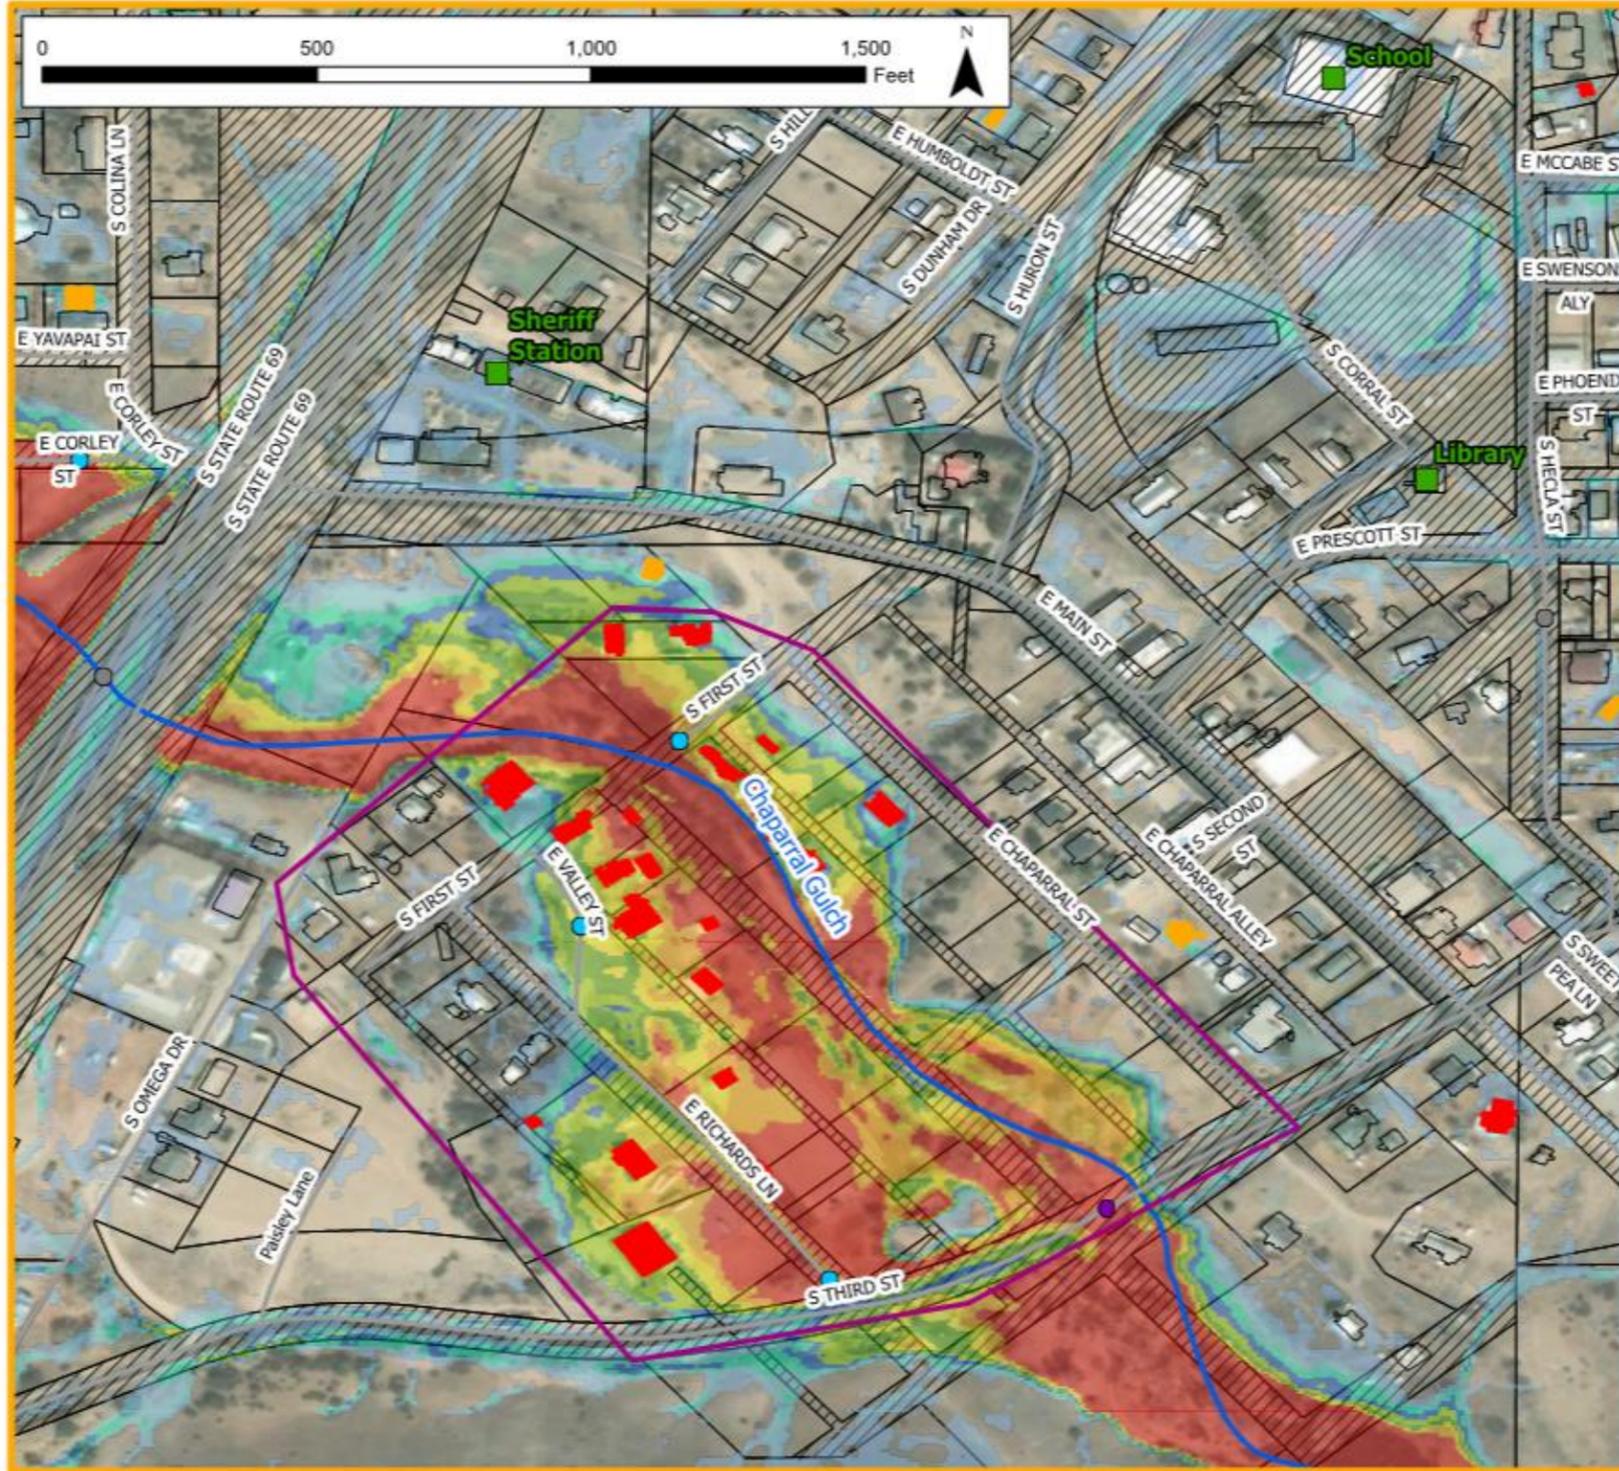
LOCATION DESCRIPTION

Location: This area includes Chaparral Gulch southwest of Main Street. The project area is bounded by Chaparral Street to the east, Third Street to the south, First Street, Valley Street, and Richards Lane to the west.

Problem Statement: This area was identified as a building hazard zone for the 100-year storm based on modeling results.

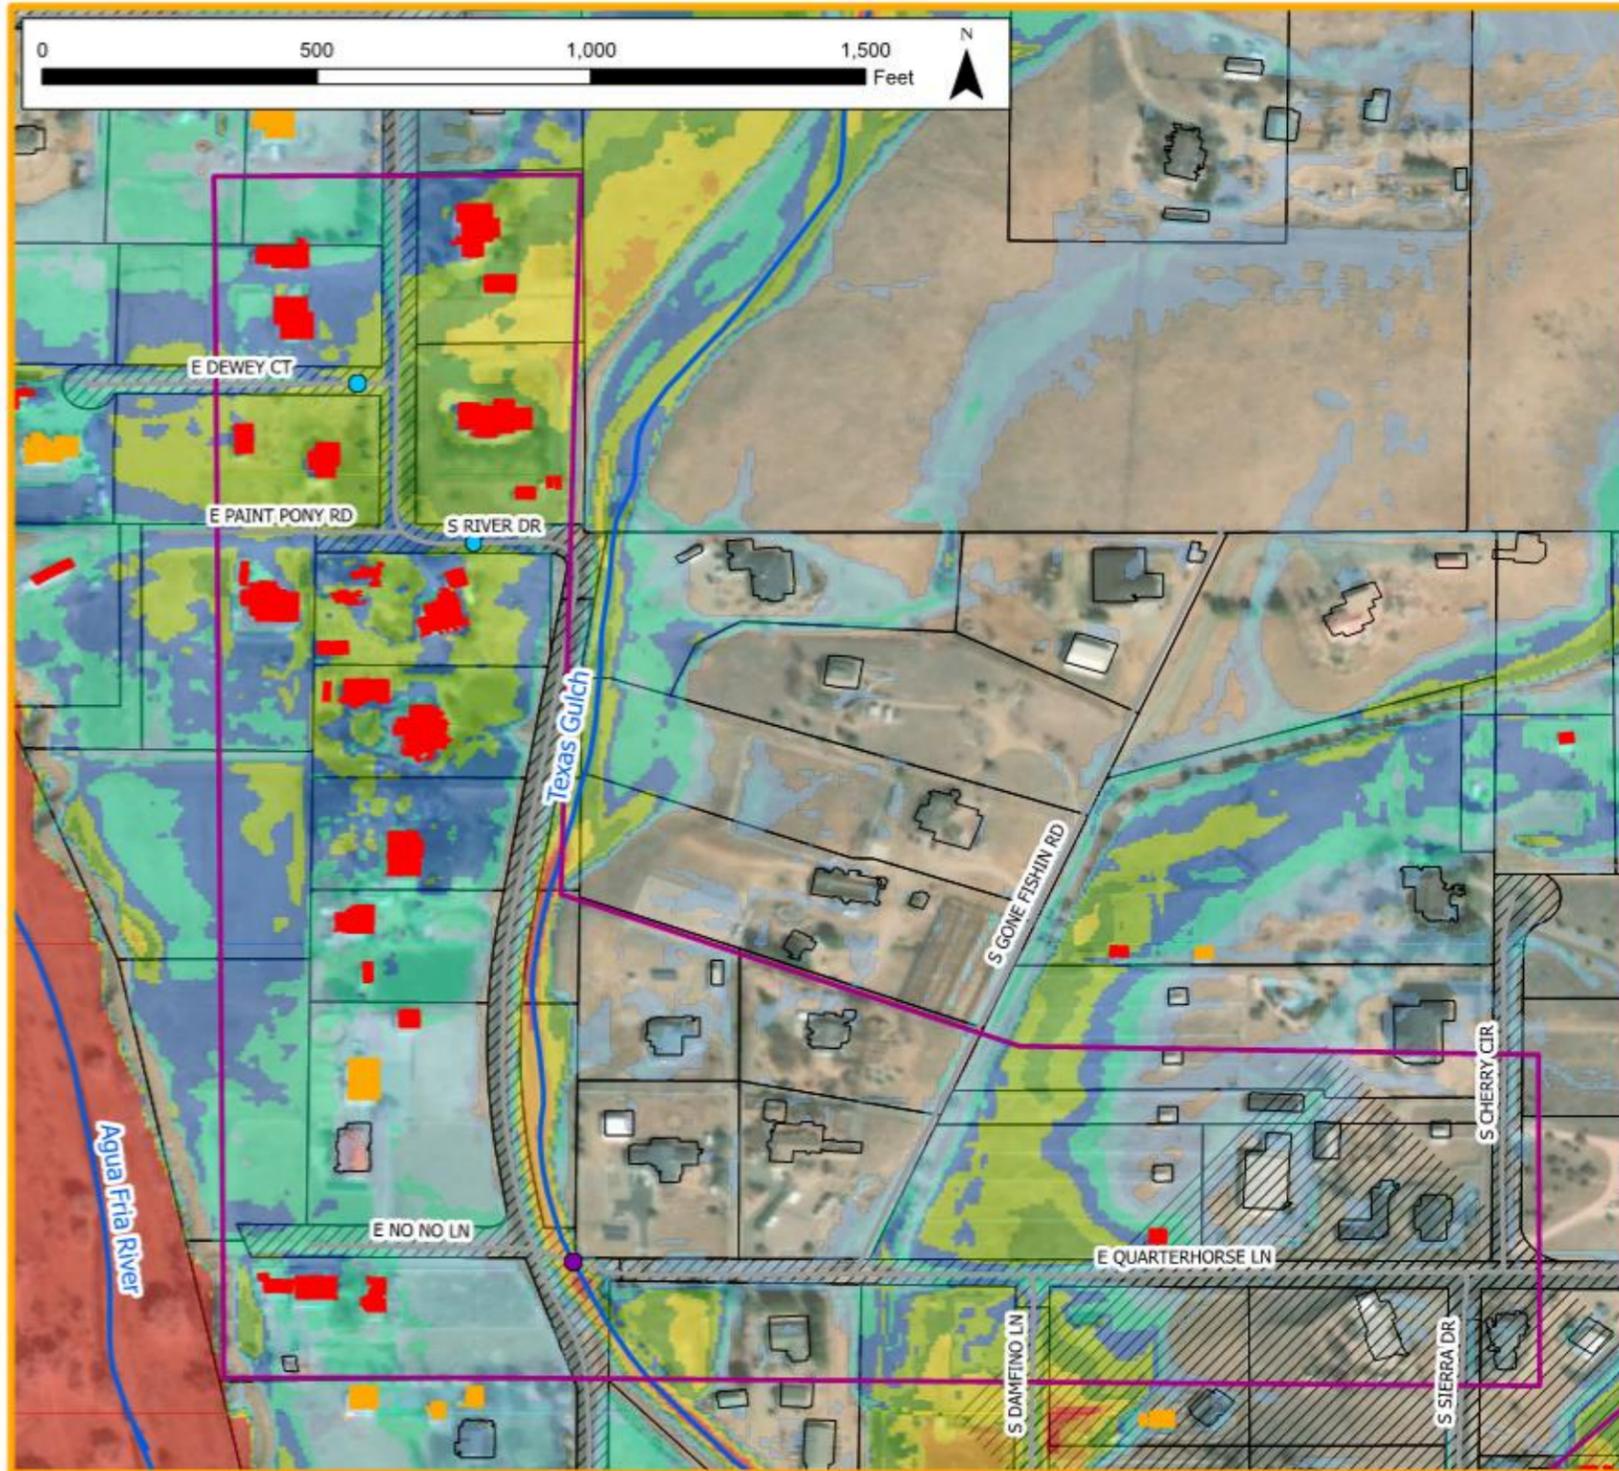
LOCATION DESCRIPTION

Location: This area includes Texas Gulch and the low water crossing at Quarterhorse Lane. It extends from the intersection of River Drive and Dewey Court in the north to the intersection of Quarterhorse Lane and No No Lane in the south and east from the intersection with River Drive along Quarterhorse Lane to where it intersects with Sierra Drive and Cherry Circle.

Problem Statement: This area was identified prior to starting the project by the Town and County. During the public meeting flow at the top of the embankment for Texas Gulch was noted. The low water crossing at the intersection of River Drive and Quarterhorse Lane was noted as a concern by the County and Town. Flooding of the S-curve of the road along River Drive has been observed to prevent vehicles making it north to SR 169.

Critical Infrastructure	Crossing Hazards	100yr Building Risks	100yr, 24hr Max Flow Depths (ft)	1.5 - 2.0
Areas of Mitigation Interest	Minimal Risk	Minimal	0 - 0.15	2.0 - 2.5
Land Ownership	Low Risk	Low	0.16 - 0.5	2.5 - 3.0
Private	Medium risk	Medium	0.5 - 1.0	3.0 - 3.5
Public	High Risk	High	1.0 - 1.5	3.5 - 4.0
				> 4.00

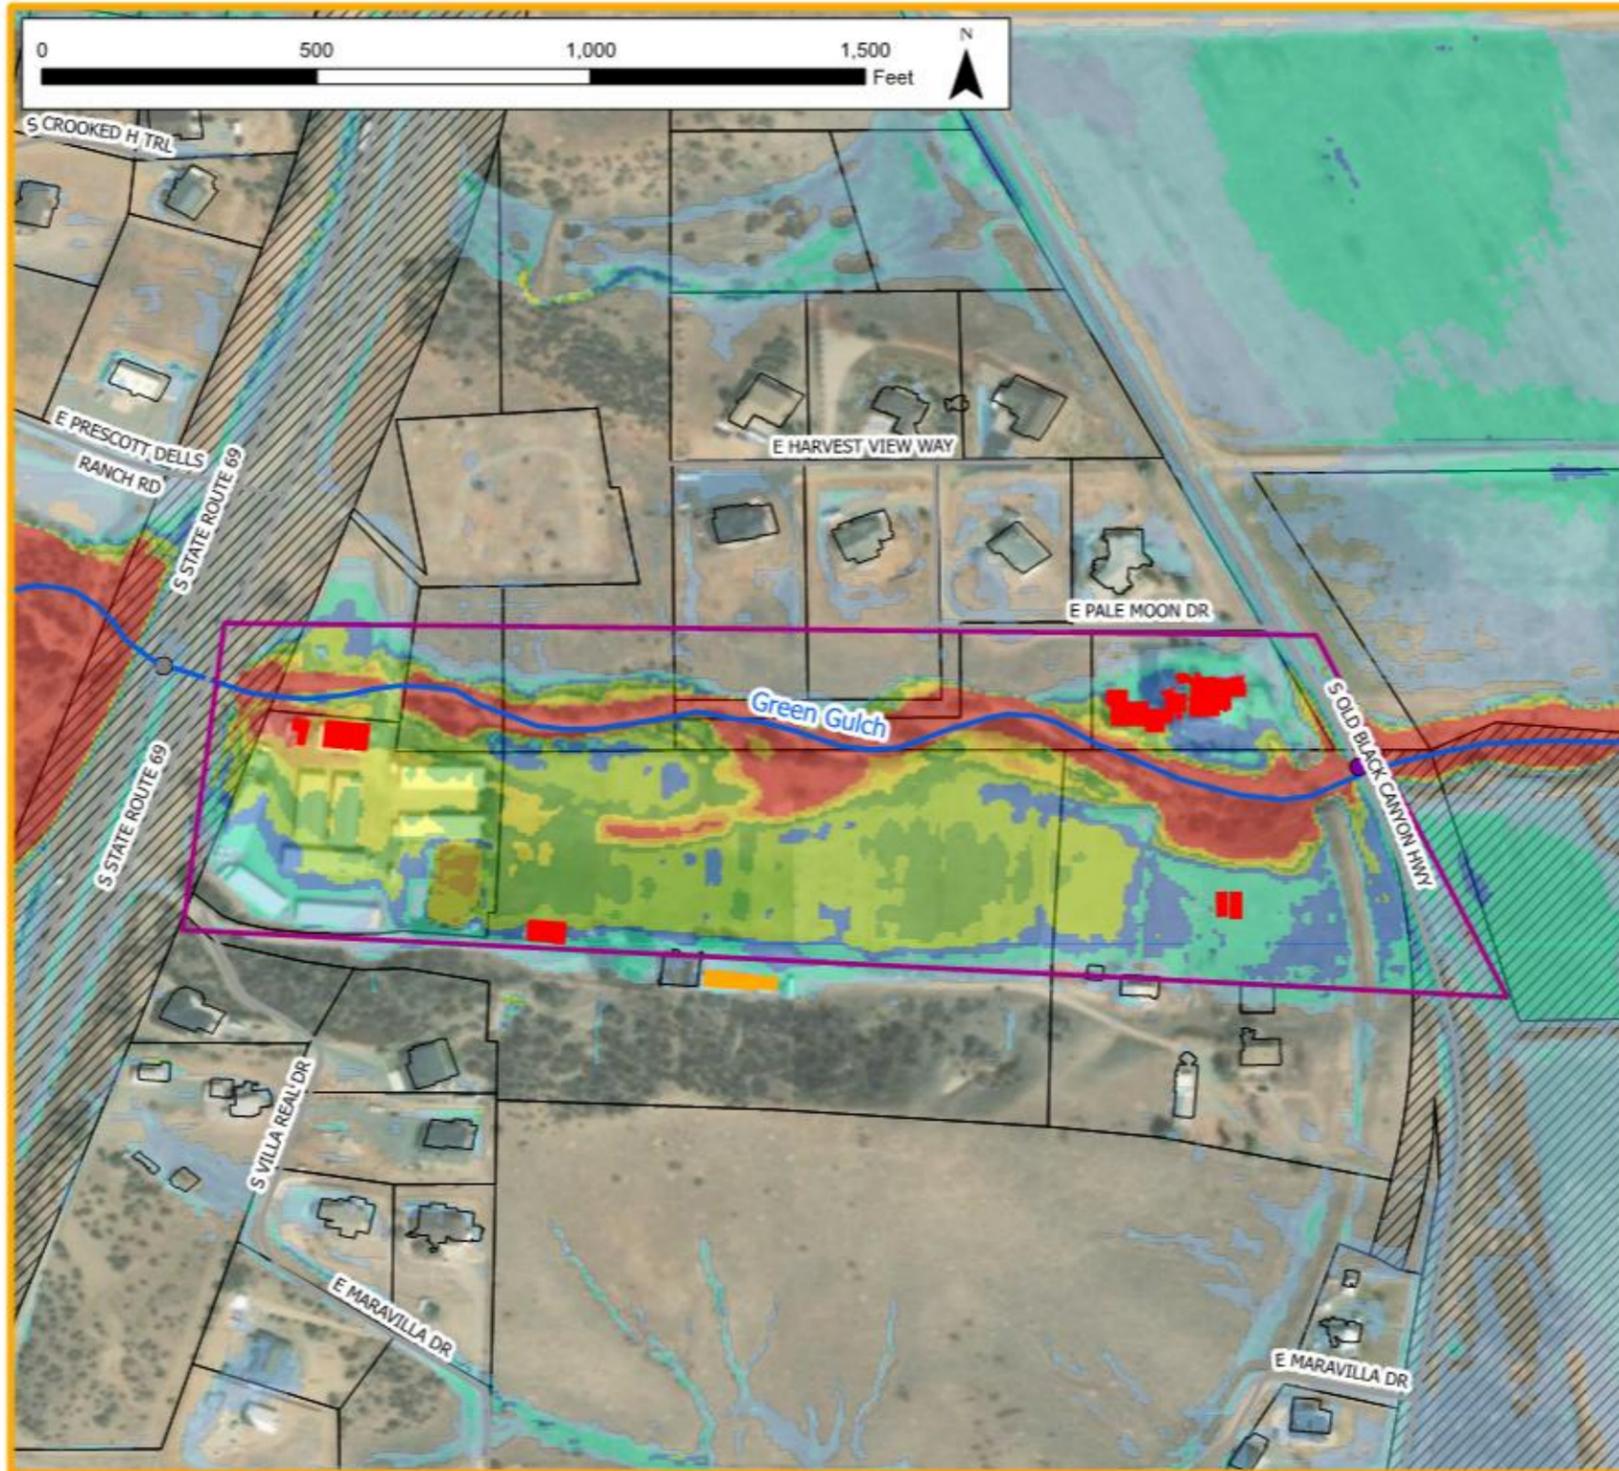
LOCATION DESCRIPTION

Location: This area includes Green Gulch downstream of SR 69. It extends from SR 69 in the west to Old Black Canyon Highway in the east. The majority of the project is on private parcels, except for Parcel 402-06-025V, which belongs to the Town.

Problem Statement: This area was identified due to flooding of buildings east of SR 69 during the 100-year storm. The area also includes a bridge over Green Gulch. It was observed that the Old Black Canyon Highway bridge had the potential to overtop during the 100-year storm.

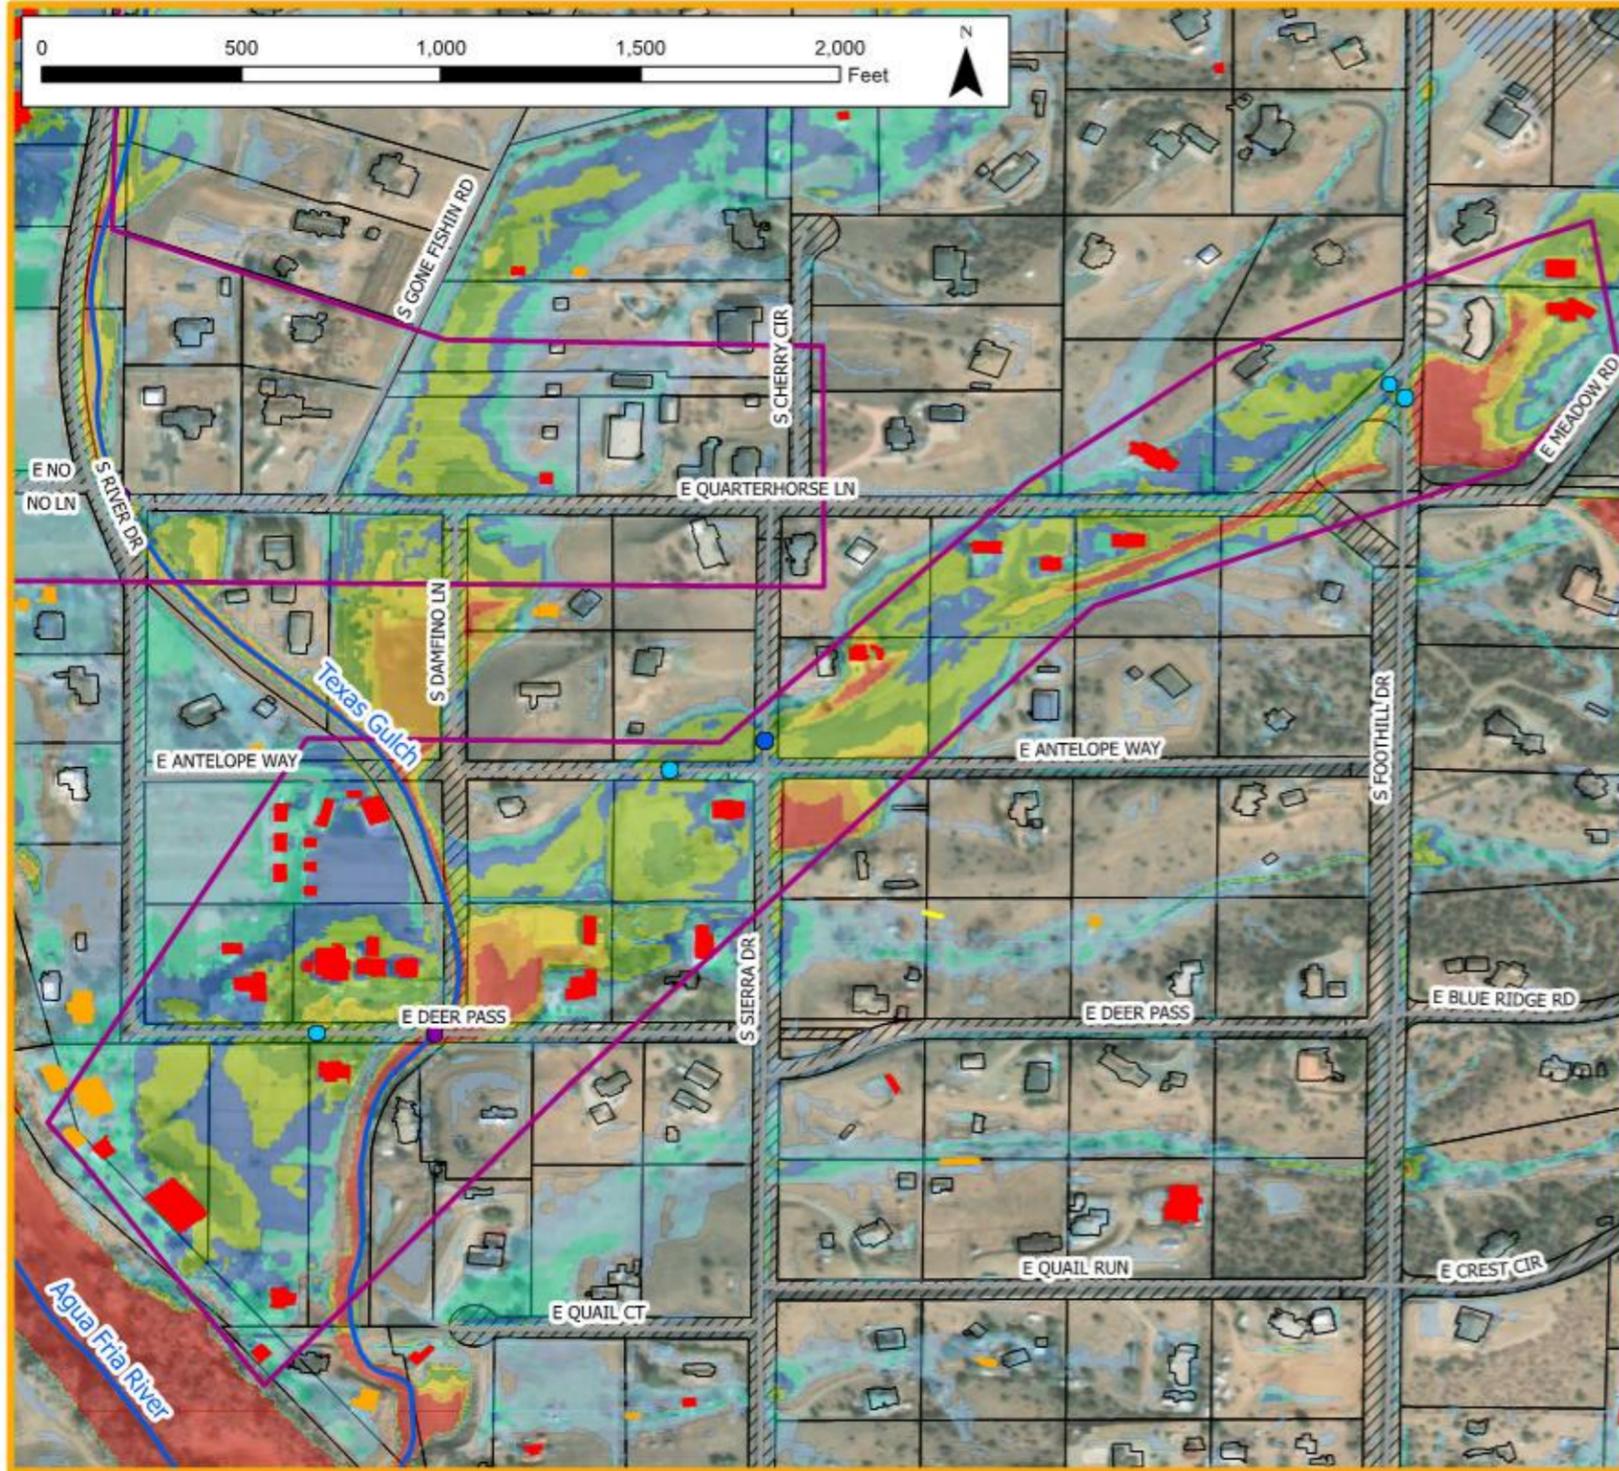
LOCATION DESCRIPTION

Location: This area includes Texas Gulch, an unnamed wash, and a residential area. The area spans from Deer Pass in the southwest to the intersection of Quarterhorse Lane and Foothills Drive in the east. It also includes a portion of Sierra Drive, Antelope Way, and Damfino Lane.

Problem Statement: This area was identified due to 100-year structure inundation and low water crossing hazards. The unnamed wash is not channelized, and the shallow wide flow impacts a number of structures.

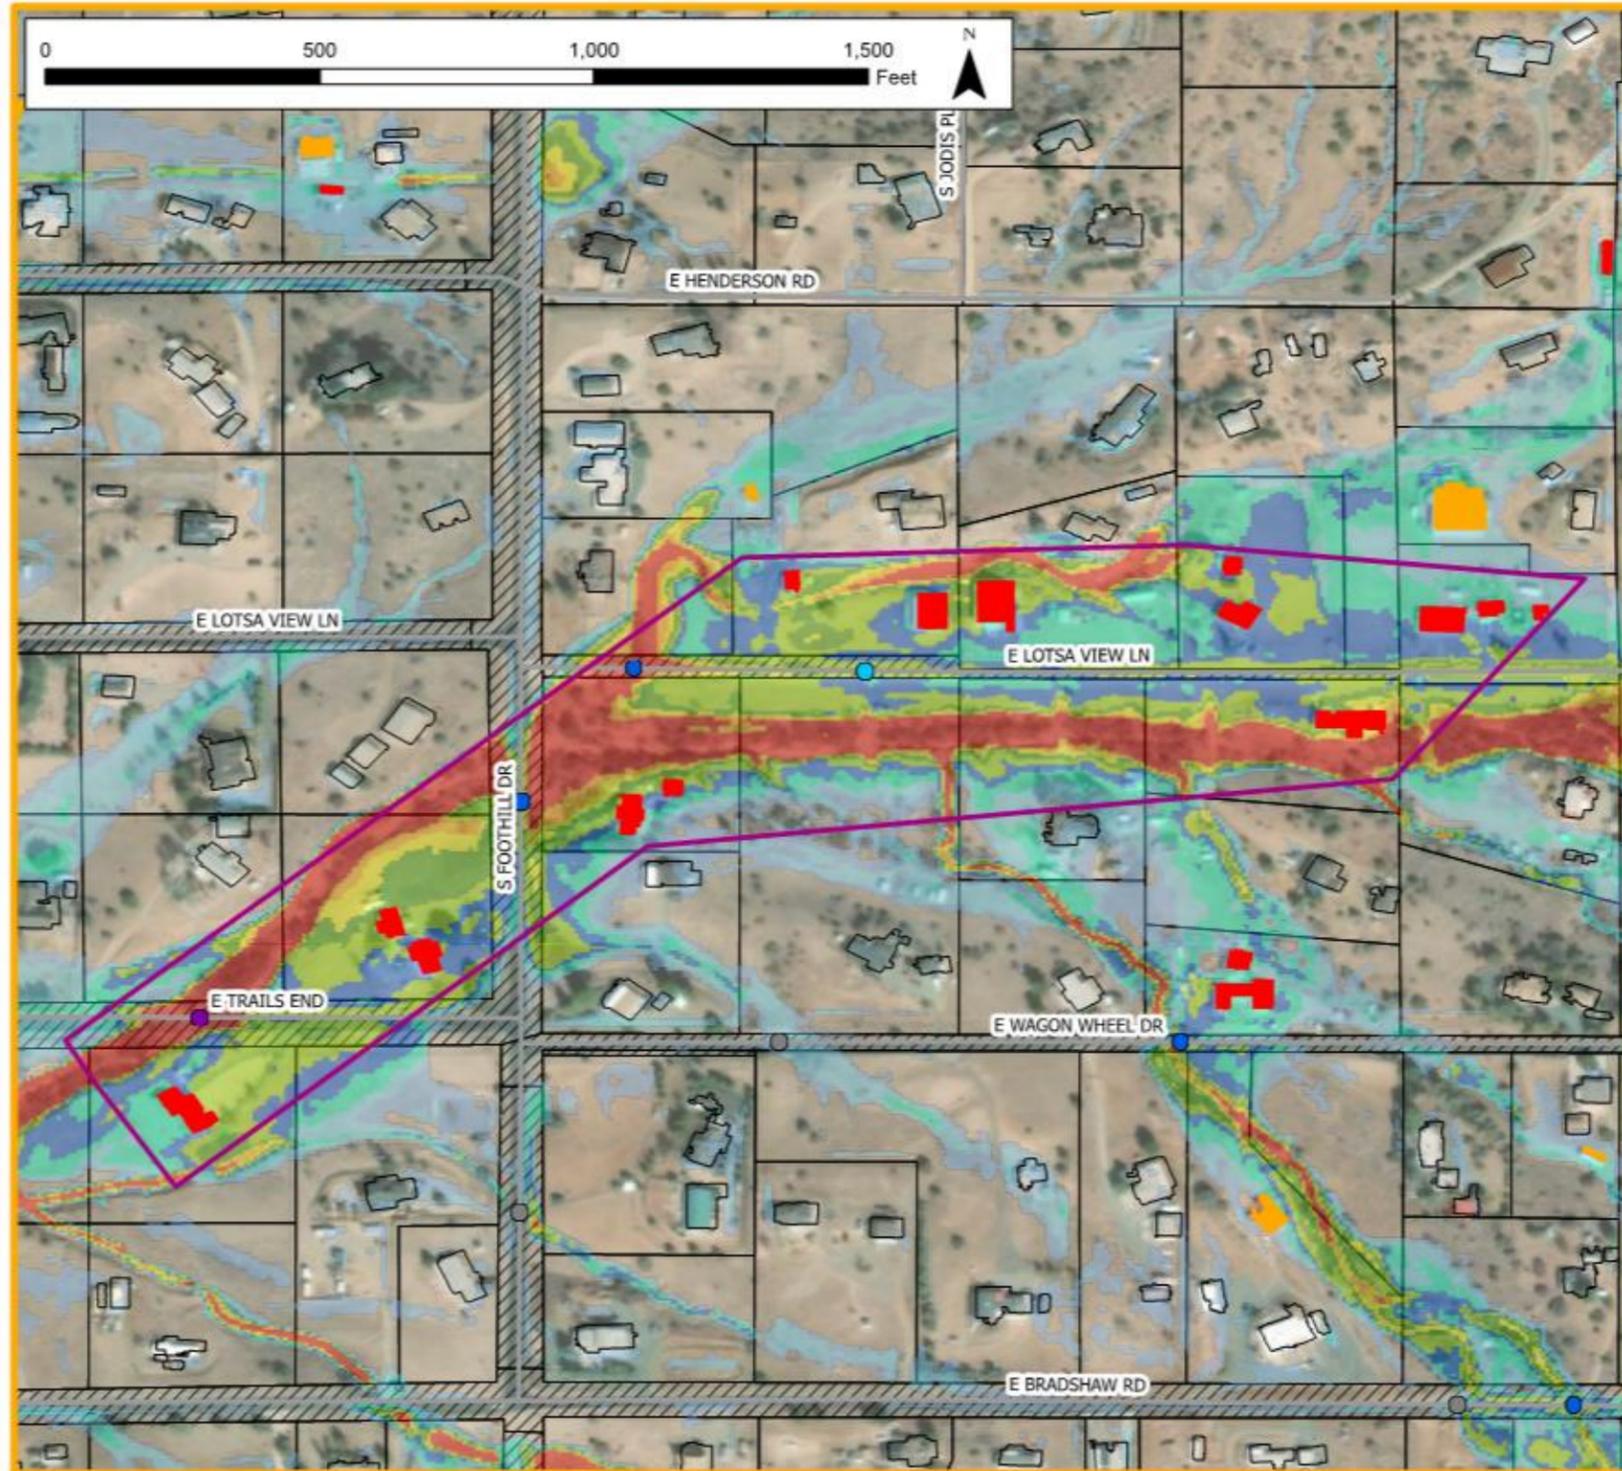
LOCATION DESCRIPTION

Location: This area includes Lotsa View Lane, Foothill Drive, and Trails End. The area also includes the unnamed wash running alongside these roads and the culverts under Foothills Drive.

Problem Statement: This area was identified due to 100-year structure inundation. There are also several low water crossings with hazardous conditions during the 100-year storm.

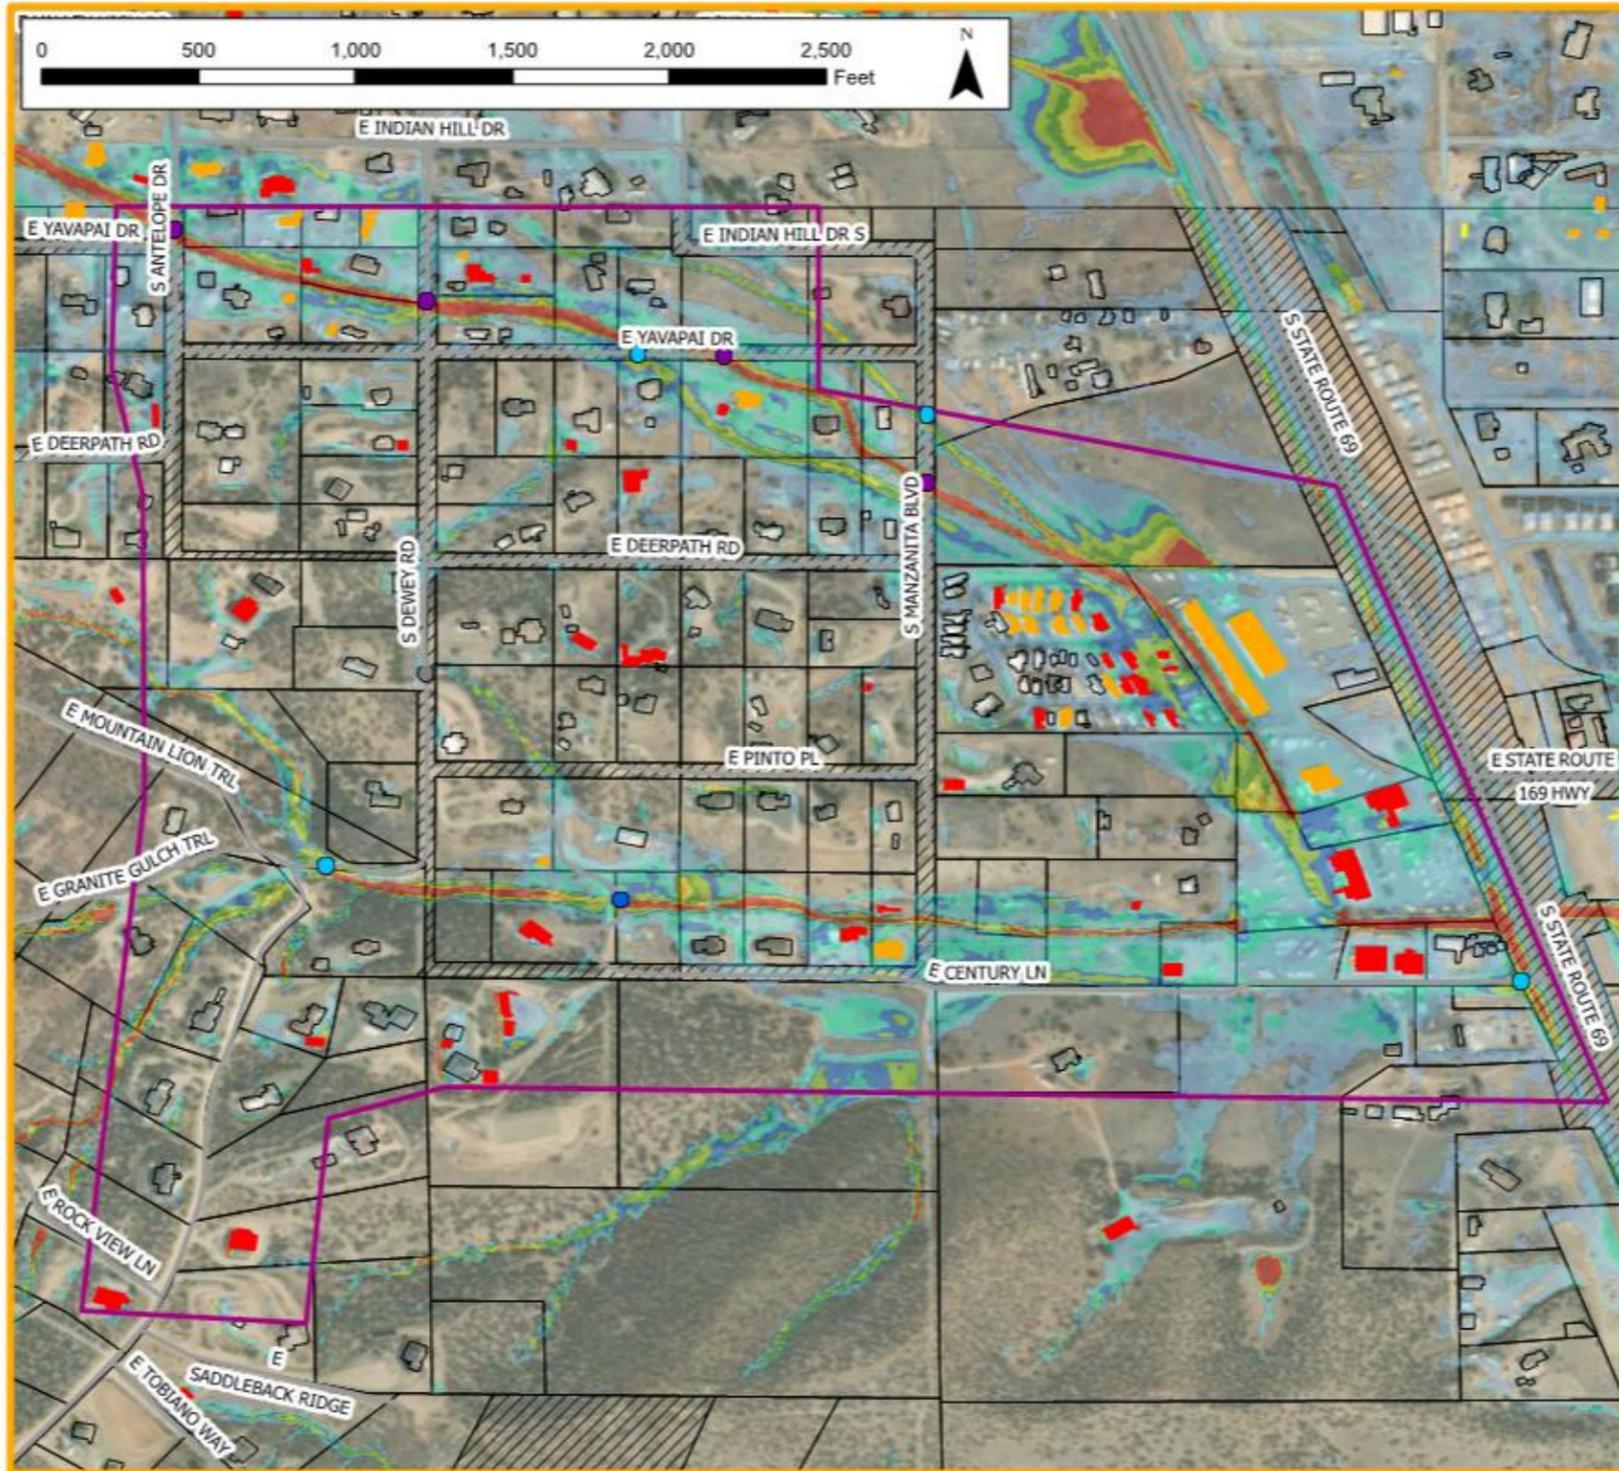
LOCATION DESCRIPTION

Location: This area includes the residential and commercial area west of SR 69 and two unnamed existing washes. The area is bounded by Dewey Road west of SR 69 and extends from the intersection of Dewey Road and Rock View Lane in the south to the intersection of Antelope Drive and Yavapai Drive in the north. The area also contains the region between SR 69 and Dewey Road.

Problem Statement: This area was identified during the hazard identification meeting with the County. Dewey Road was noted as one of the major access roads to the developments located west of SR 69, with several road crossings impacted by the 2-year storm. There are also structures impacted by discharge breaking out of the unnamed washes.

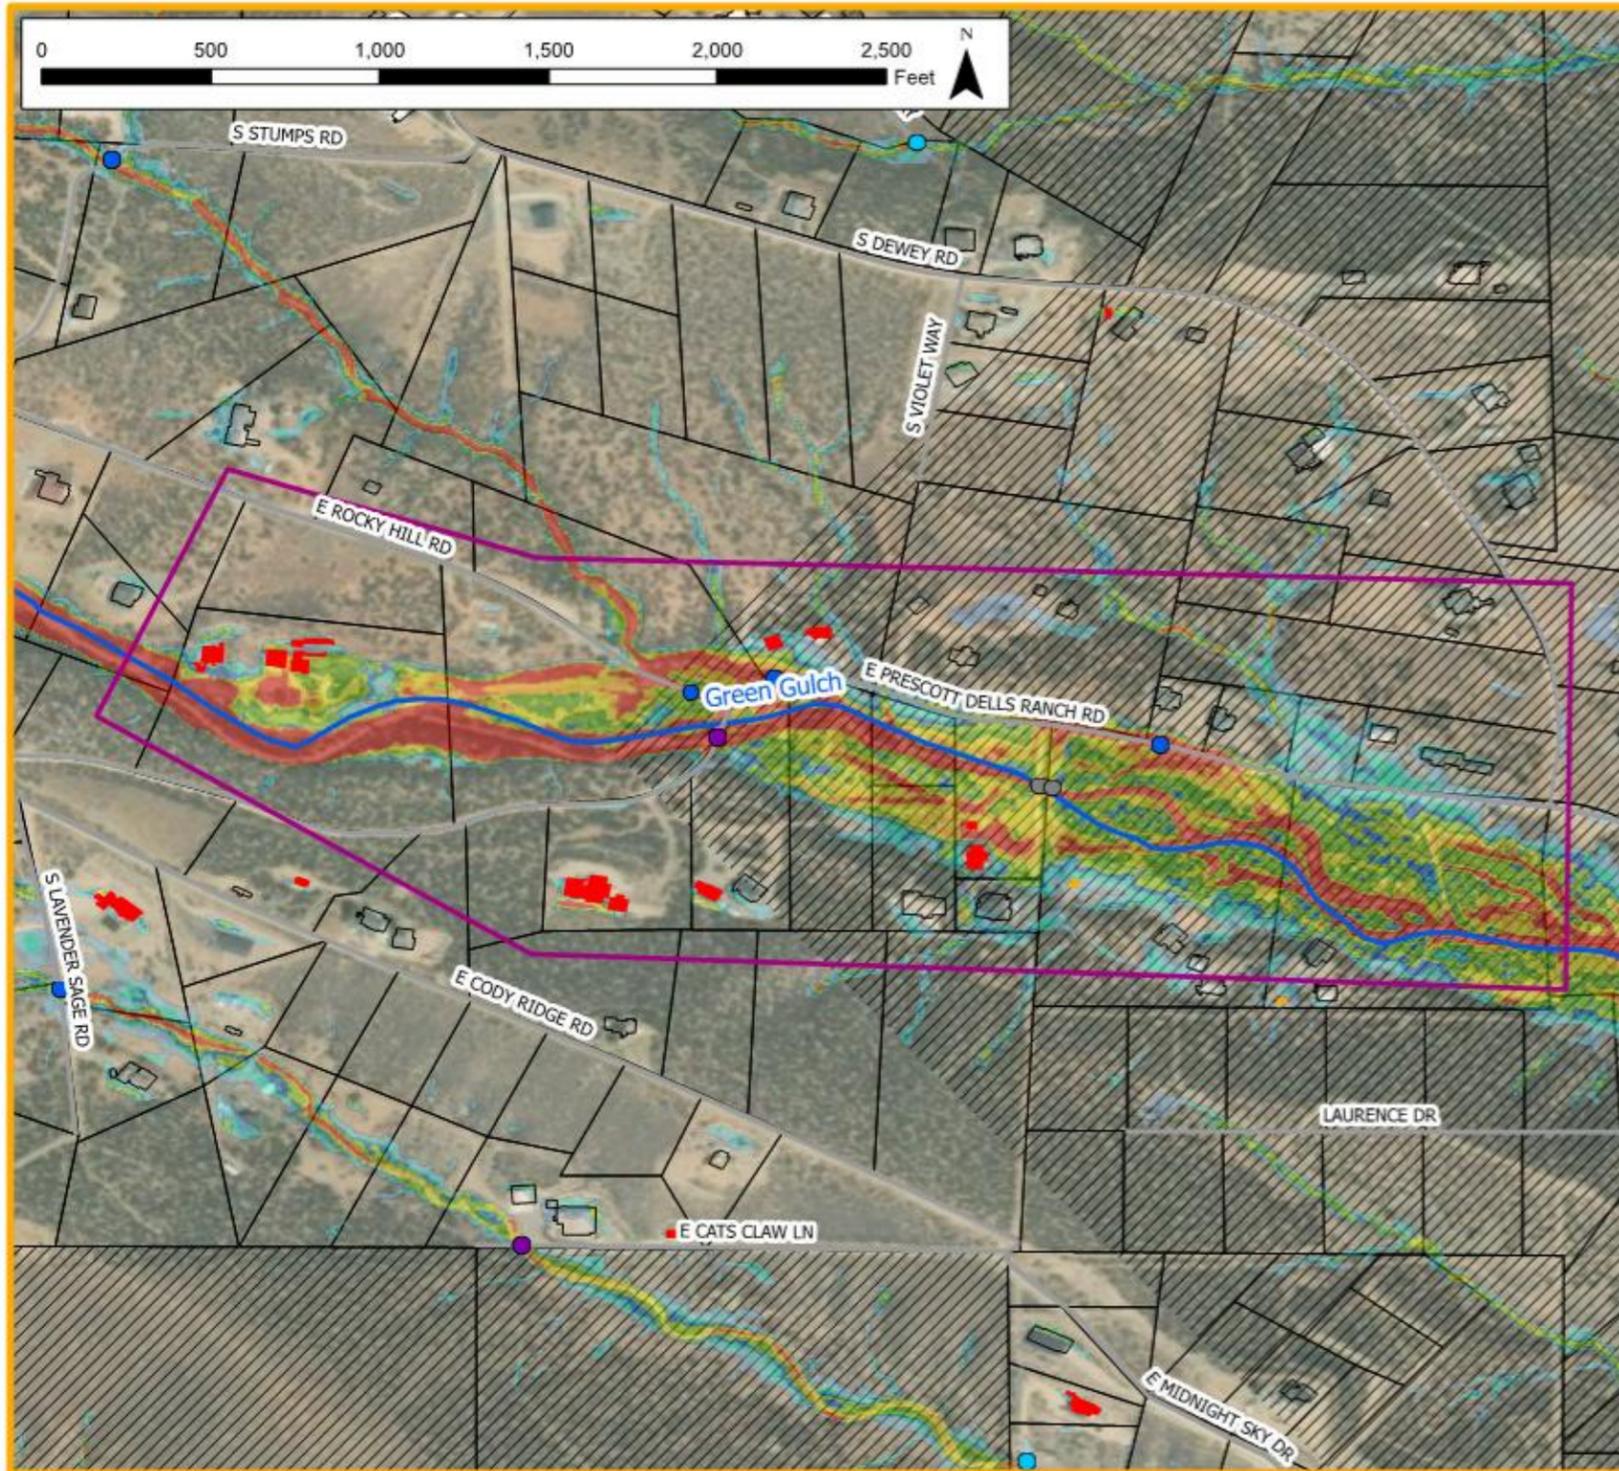
LOCATION DESCRIPTION

Location: This area includes Green Gulch and Prescott Dells Ranch Road and its intersection with Rocky Hill Road. The area extends along Prescott Dells Ranch Road from the intersection with Dewey Road in the east, past its intersection with Rocky Hill Road, for a length of approximately 1,300 feet.

Problem Statement: This area was identified during the hazard identification meeting with the County. It was noted that Prescott Dells Ranch Road is one of the only access roads to Blue Hills Farms, located west of the study area. There is a low water crossing at Prescott Dells Ranch Road that experiences hazardous conditions during the 2-year storm event.
