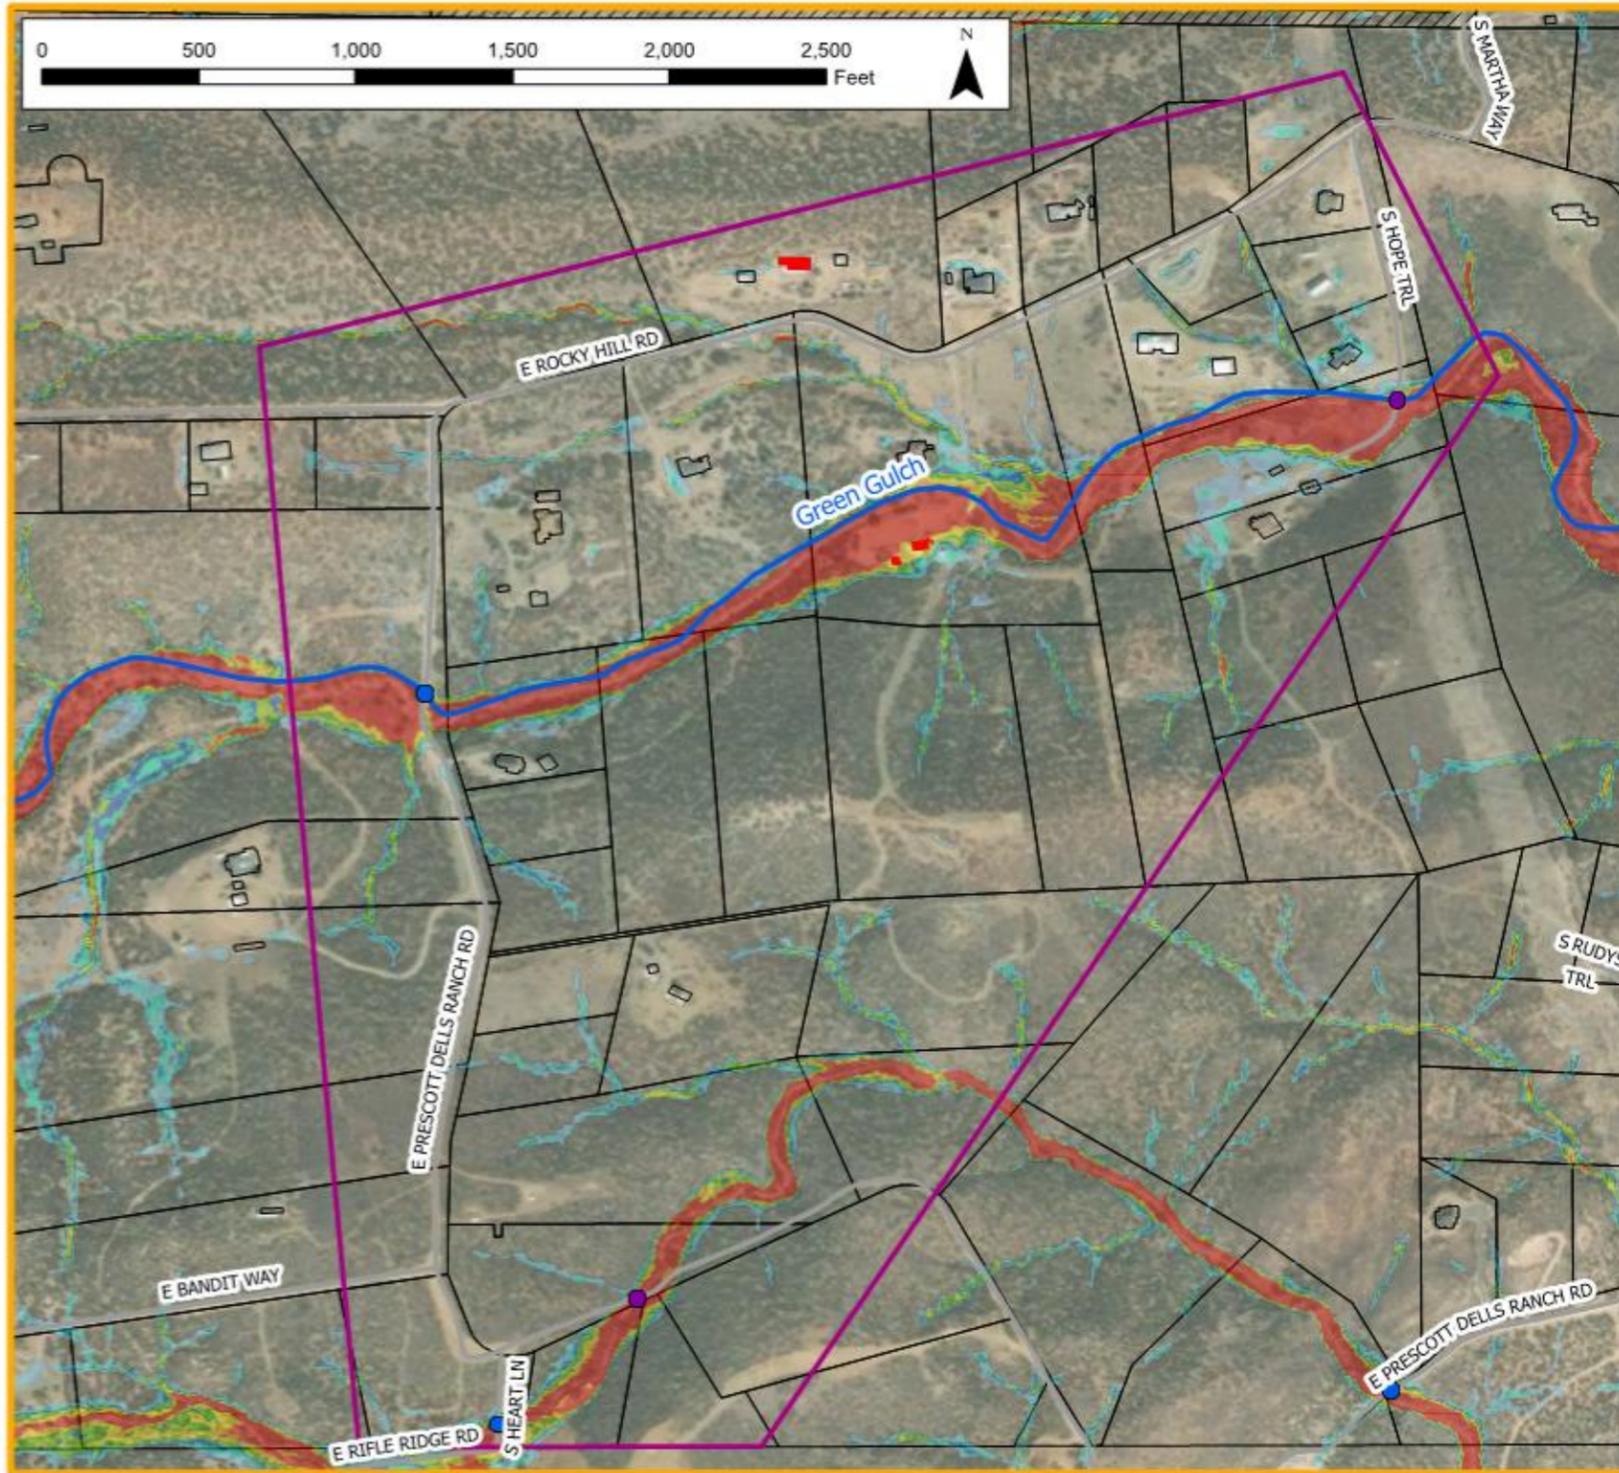
LOCATION DESCRIPTION

Location: This area includes Green Gulch and Prescott Dells Ranch Road and its intersections with Heart Lane and Bandit Way. The project area extends along Prescott Dells Ranch Road from the intersection with Rocky Hill Road in the north to where Rocky Hill Road intersects with Hope Trail in the east.

Problem Statement: This area was identified during the hazard identification meeting with the County. It was noted that Prescott Dells Ranch Road is one of the only access roads to Blue Hills Farms, located west of the study area. Prescott Dells Ranch Road and Hope Trail experience flooding at crossings with Green Gulch.
